The dangers of exposure to asbestos in vermiculite attic insulation

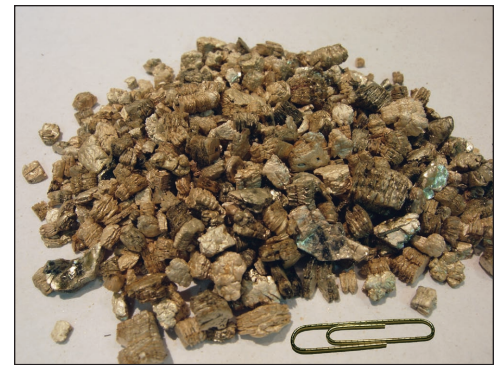
Vermiculite insulation

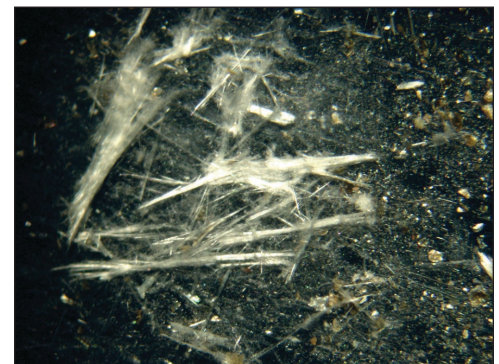
Asbestos fibres from vermiculite insulation

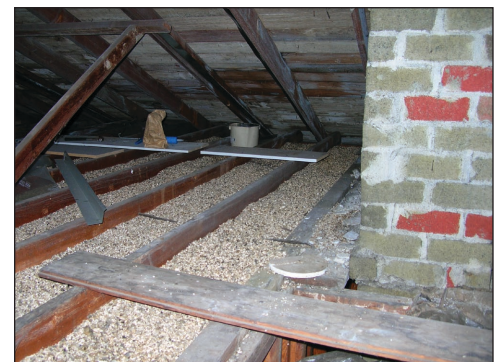
Typical vermiculite insulation in an attic

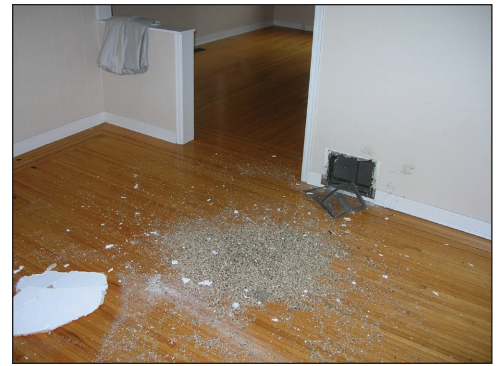
Vermiculite insulation spilled from an attic during a renovation

Vermiculite insulation containing asbestos must be removed by experienced asbestos abatement contractors before any renovations or demolition takes place. You are responsible if unprotected workers are exposed to asbestos-containing building materials (including vermiculite) while working in your home or on your worksite.

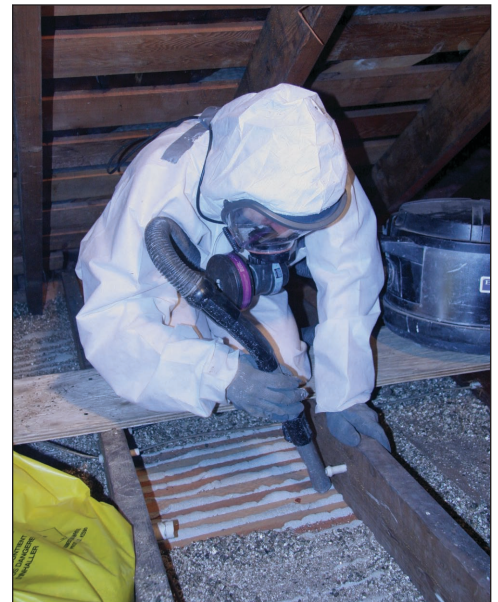
Protected asbestos worker removing vermiculite insulation from an attic
